A clinical case involving severe erosion of the maxillary anterior teeth restored with direct composite resin restorations

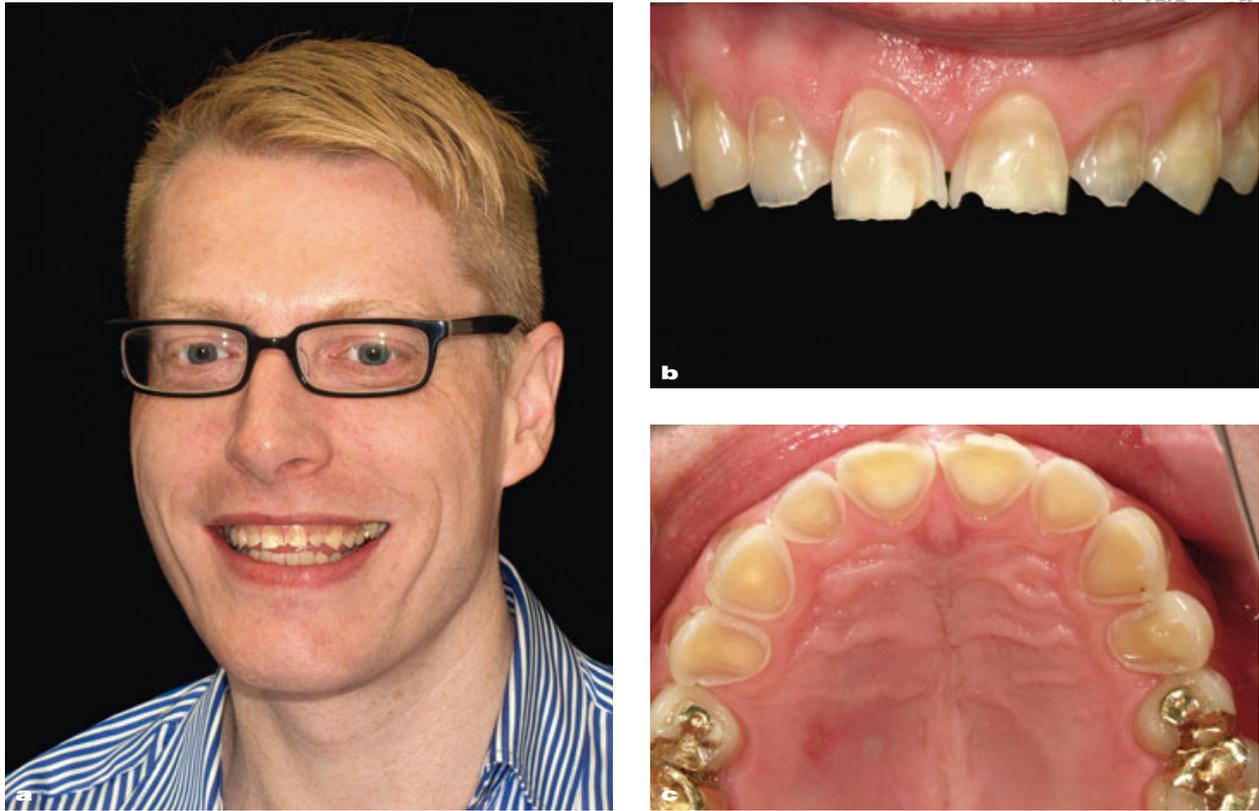
Fig 1 (a) The patient's initial appearance. There is significant loss of tooth substrate noticeable from this portrait view. (b) The condition of the teeth clearly demonstrates the damage and loss of tooth structure due to erosion. (c) The palatal view shows the complete loss of enamel and the near exposure of the pulp of all anterior teeth. The enamel border presence is a classical presentation of extensive erosion.

When tooth surface loss occurs,¹ it can be clinically challenging to isolate a single etiological factor since it is usually multifactorial in origin. The patient presented with the classic signs of erosion (Fig 1a). A major causative factor of this erosion was a large consumption of carbonated beverages on a daily basis over a number of years. Chronic exposure of dental hard tissues to acidic substrates led to extensive enamel and dentin loss from both intrinsic and extrinsic sources (Fig 1b and c). The ACE classification guides the clinician on the management options of treatment modalities, which are dependent on the severity of the erosion.²

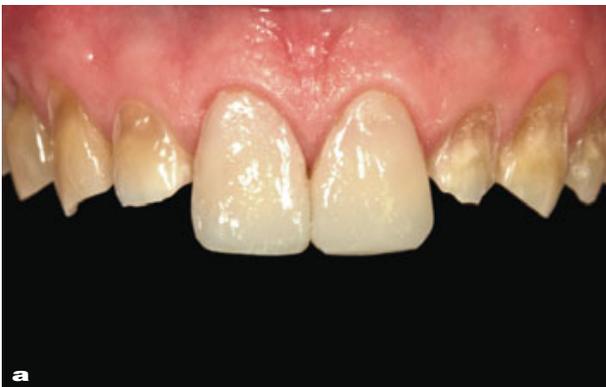
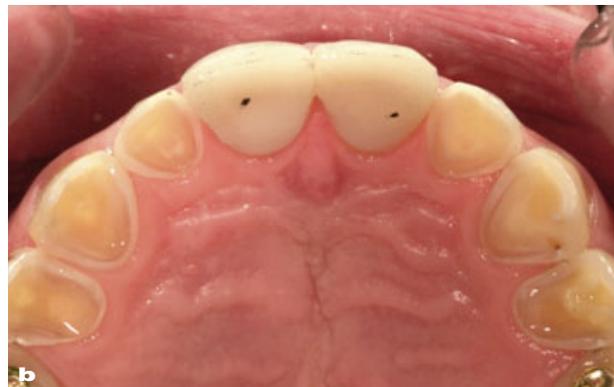
Fig 3 (a) Direct mock-up in composite resin of the central incisors. This was done to give an idea of how much length could be provided in relation to the lip and smile line. It also enabled the assessment of the form in relation to the photographs provided. **(b)** The palatal view of the direct composite mock-up, which shows the extent of the addition of material that was possible.

In this case, the intraoral mock-up served as a template to create a silicone index into which the composite resin restorations could be built (Fig 3a and b). This avoided additional costs for the patient, and reduced the timescale involved (the treatment was an urgent priority for the patient, who had become extremely conscious of his smile). The composite resin mock-up of tooth 21 was left *in situ* for tooth 11 to be built up, again under rubber dam. This served to provide more control of the midline and maintain better control of form. This is helpful when placing extensive challenging freehand composites. The composite resin on tooth 11 could be provisionally finished to obtain the final outline form; the same could then be carried out on tooth 21. Once tooth 21 was restored, a direct composite resin mock-up of teeth 12, 13, 22, and 23 was fabricated, and a new silicone putty index

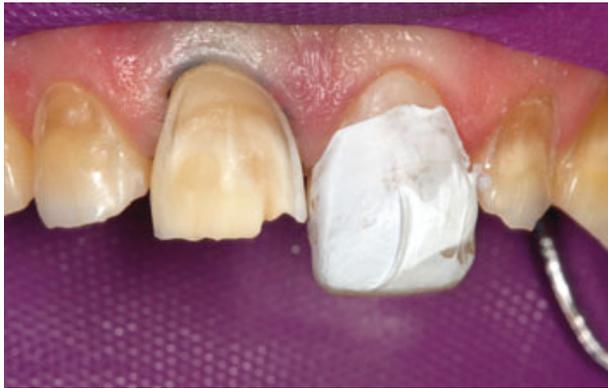
Fig 4 A silicone putty index was made from the mock-up. Then, split rubber dam could be applied and the composite resin mock-up of the maxillary right central incisor removed, while leaving the mock-up of the left central incisor *in situ*. This allowed for good control of the midline position and contact areas. This restoration would be completed with basic polishing. Then, the same was repeated for the maxillary left central incisor, after which a new direct mock-up was performed for the maxillary lateral incisors and canines. Each tooth was restored individually.

was made, into which each restoration could be built. Each tooth was restored individually under rubber dam (Fig 4).

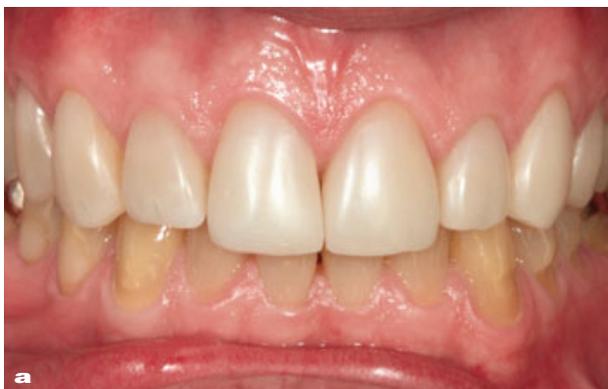
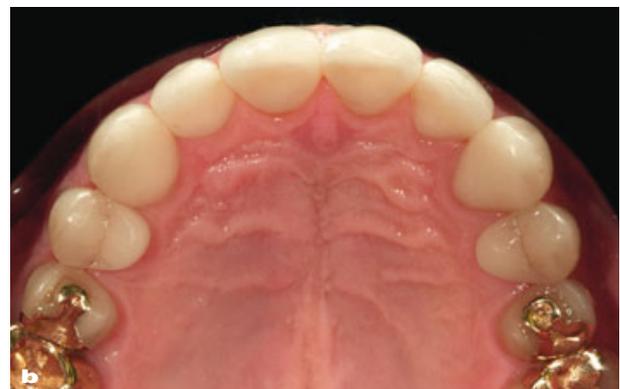
Fig 5 (a) At 1 year. This photograph was taken with the teeth dried and without polishing or refurbishment having been carried out. Note the reduction of the luster over this time, and also the lack of depth of the restorations due to the loss of luster. **(b)** Occlusal view at 1 year.

Composite resin does not have the same long-term esthetic performance as ceramics. Therefore, it must be stressed from the outset that refurbishment will be required in the future to maintain these restorations.⁵ All the photographs shown here were taken with the teeth dried, and prior to any polishing or refurbishing procedures (Figs 5 to 10). They clearly show the changes of the composite resin surface that occurred over time. It must also be noted that the material

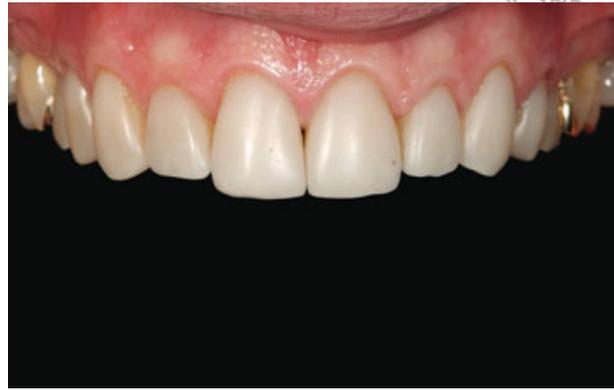
Fig 7 Close up of the maxillary teeth at 5 years, being the postoperative view taken in a dry field. Once again, note the lack of luster, areas of filler plucking, and increased opacity of the restorations.

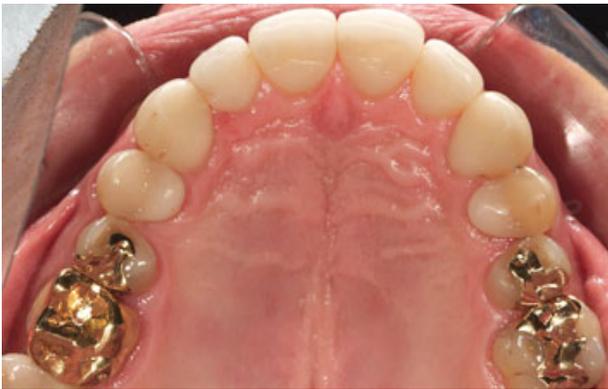
Fig 8 Maxillary occlusal view at 5 years. Physiological wear over time can be noted by the areas of wear facets and indentations on the aging composites. Note the bulk of material and thickness of the incisal edges. Thicker incisal edges in composite resin significantly reduce the incidence of chipping. The existing gold restorations did not require replacement.

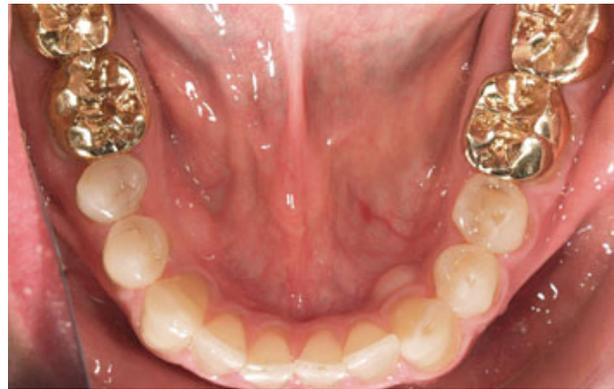
Fig 9 Mandibular occlusal view at 5 years. The patient still has not had cervical restorations or the canine riser addition on the mandibular left side restored. The existing gold restorations are still functioning.

When the patient is ready to do so at a later date, a refurbishment will be required, as well as the completion of the rest of the original plan. Furthermore, this working model can be copied in the future when ceramic restorations or hybrid-type sandwich restorations are eventually selected.⁶⁻⁸
